### **LAS VEGAS VALLEY WATERSHED ADVISORY COMMITTEE**

# Weir Life Span Assessment

Las Vegas Valley Watershed Advisory Committee

January 27, 2026

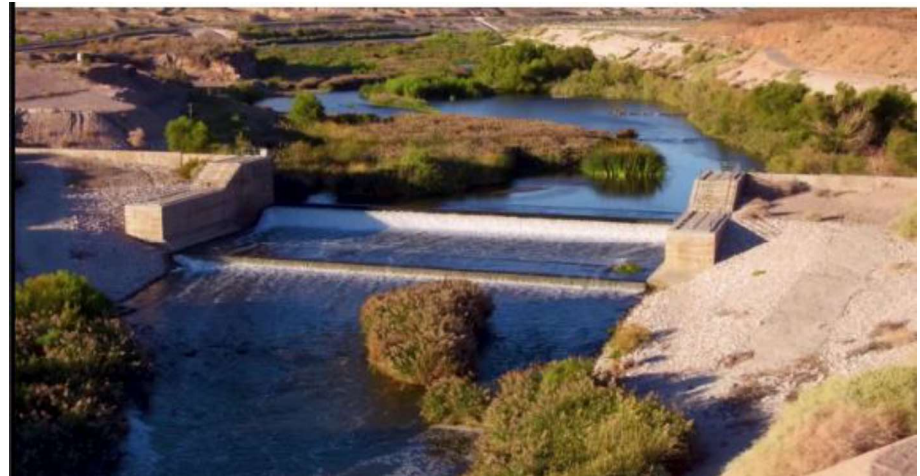
# Structure Types

- Flexible Rip Rap (Confined vs Unconfined)
- Concrete skinned Gabian
- Roller Compacted Concrete (RCC)
- All contain a sheet pile cut off wall, which is the linchpin of the structure
